**CRASH INJURY INVESTIGATION**

**HU-1A BELL IROQUOIS HELICOPTER ACCIDENT**

**East St. Louis, Illinois**

**21 October 1959**

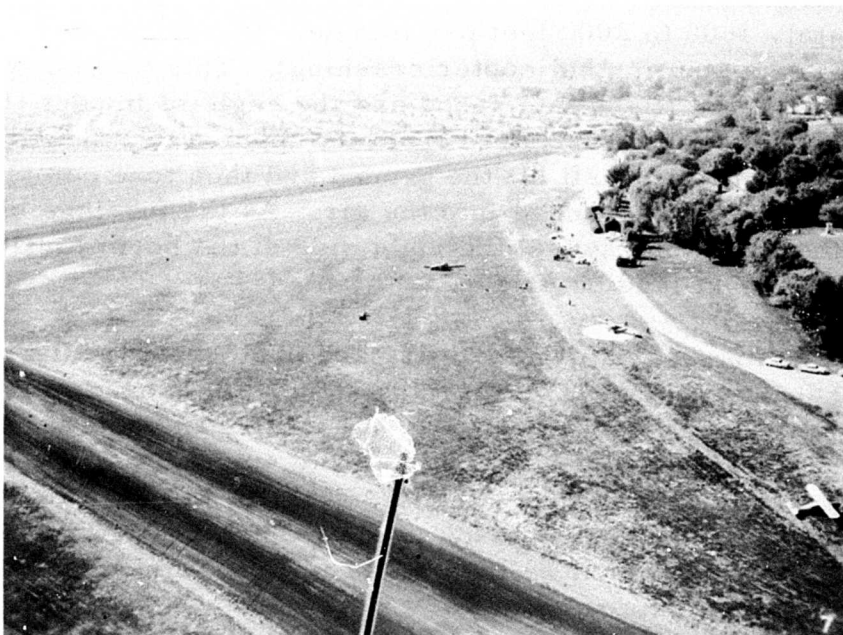
Fig. 1. The aircraft approached the field as indicated by the arrow.

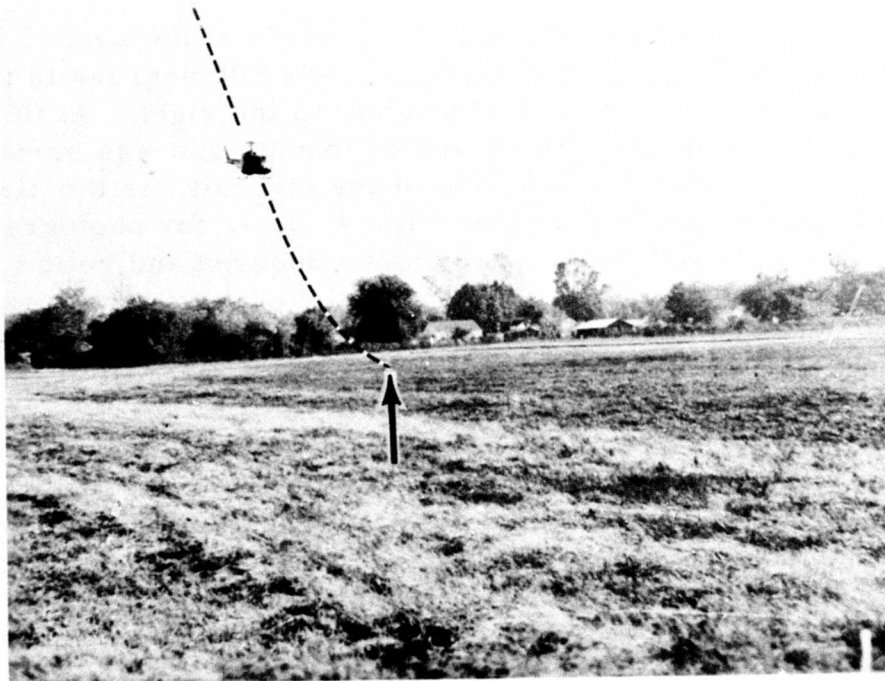
Fig. 2. HU-1A descending to initial impact. Dotted line indicates approximate flight path (determined as closely as possible through photographic analysis). The arrow indicates point of impact.

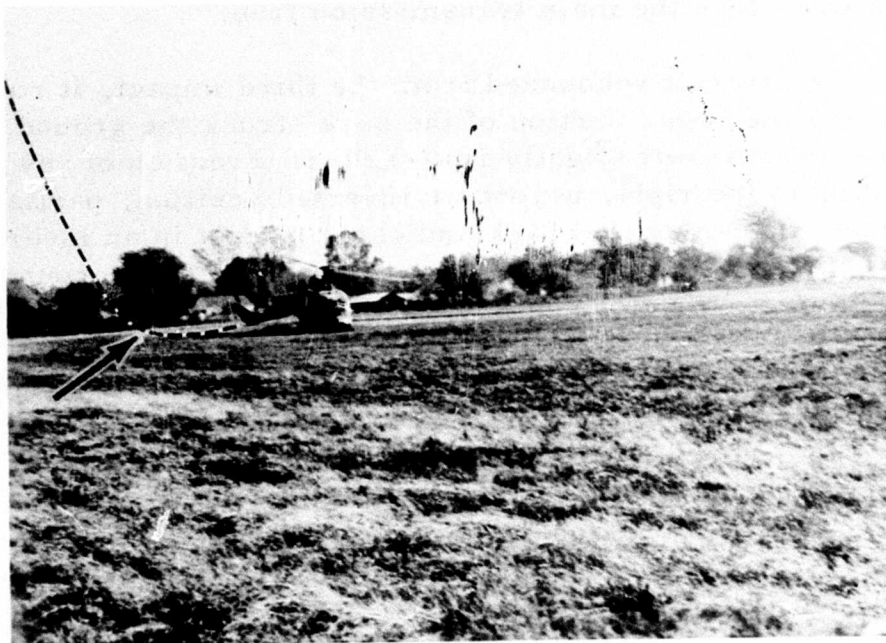
Fig. 3. HU-1A shown rebounding off ground after initial impact. Tail boom is broken downward; fuselage begins turning clockwise. Initial impact gouge indicates aircraft rode on ground at least 12 feet before rebounding back into the air. (Refer to Fig. 8, p. 9).

The tail cone and tail rotor assembly broke free as a unit during the initial impact, and the right side of the tail boom was subjected to a great deal of structural damage. (For action photograph of assembly breaking see Fig. 3, p. 6).

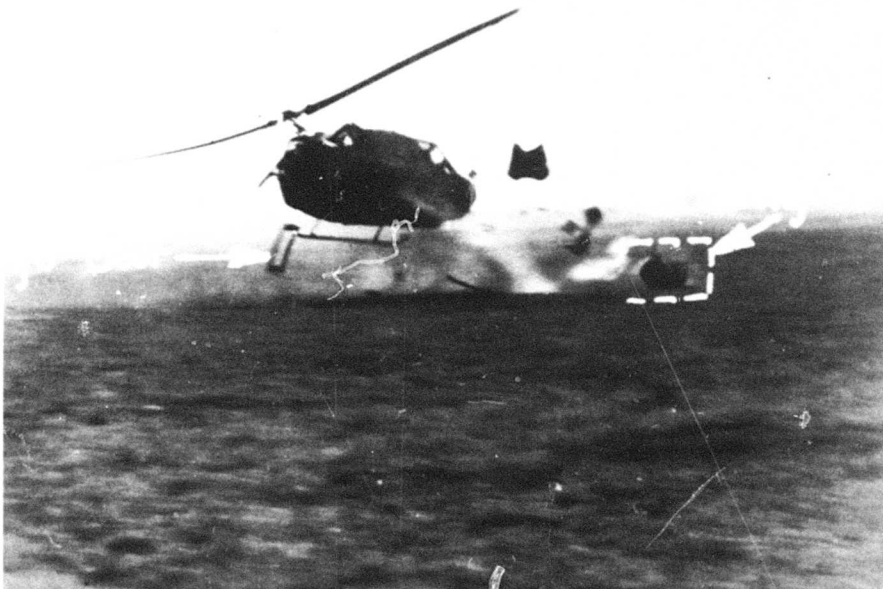
Fig. 4. View of right side and underside of HU-1A (nose is at the right), airborne after second impact about 350 feet along crash path. Note that engine is torn free, hurtling ahead of fuselage; slight displacement of rotor head to left is indicated.

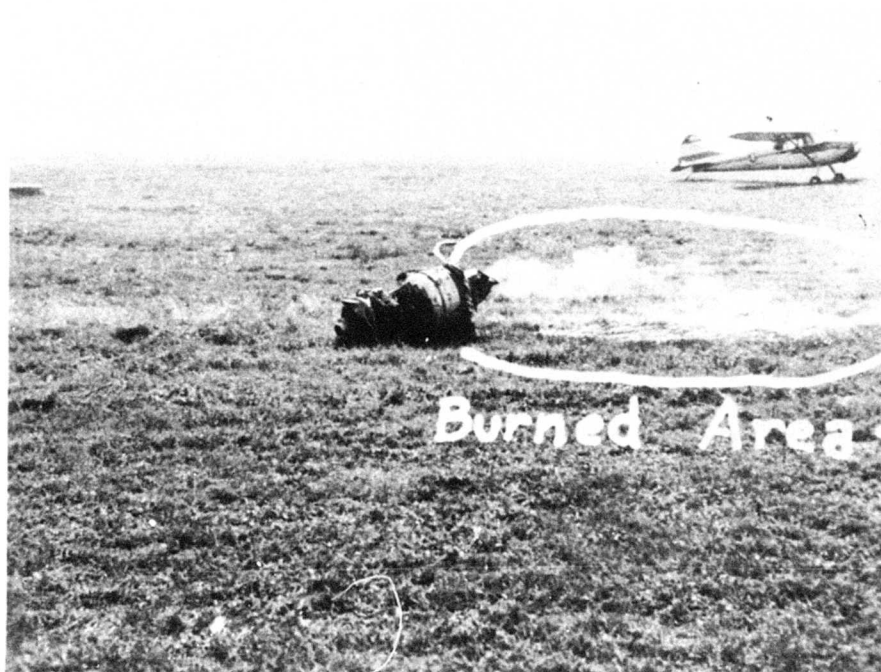
Fig. 7. Engine continued to run for a few seconds after being torn free.

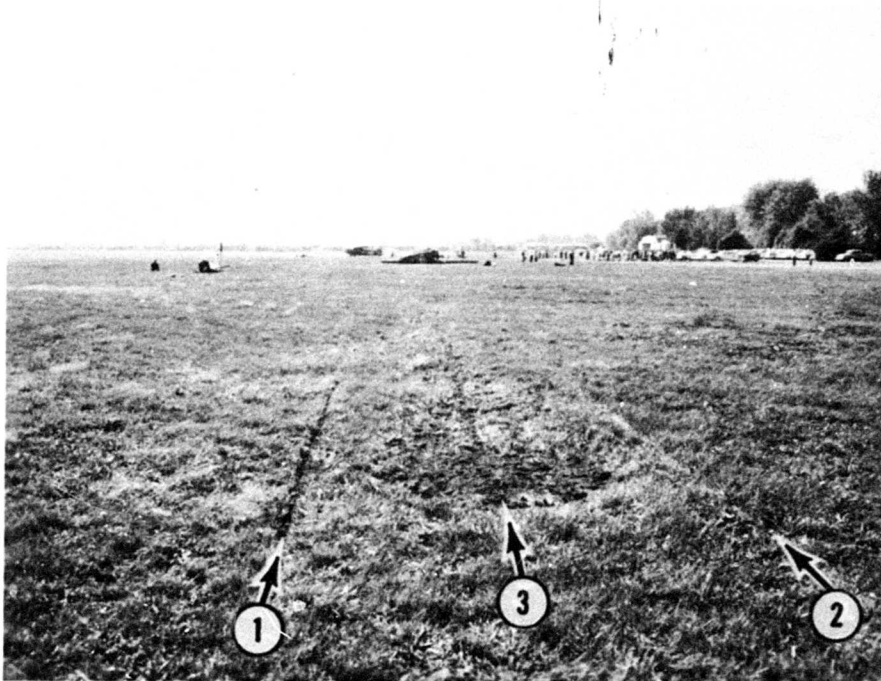
Gouge marks, damage details, and photographic interpretation indicate that the bottom of the fuselage struck the ground at the initial impact. (For gouge marks, see Fig. 8, p. 9). The skids and cross tubes seem to have absorbed a considerable amount of crash force. Rebounding from the initial impact, the aircraft was in a 20- to 25-degree nose-down attitude, yawing to the right. The left and right forward doors, torn partially free in the impact, were thrown completely free during this rebound.

Fig. 8. Initial impact area. Arrow 1 indicates the left skid mark; arrow 2, the right skid mark; and arrow 3, the fuselage gouge.

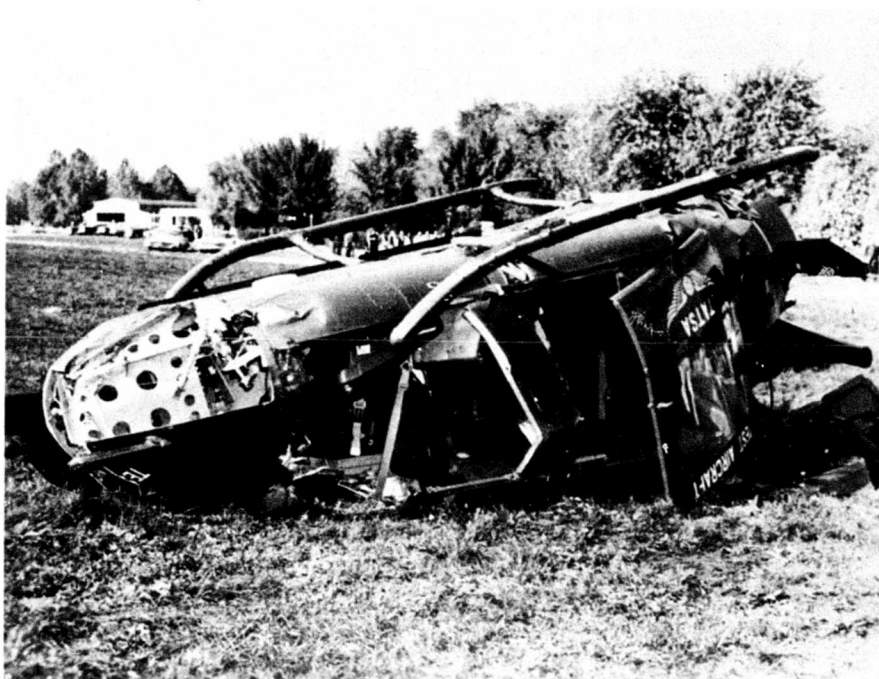
Fig. 9. HU-1A as it came to rest in an inverted position.

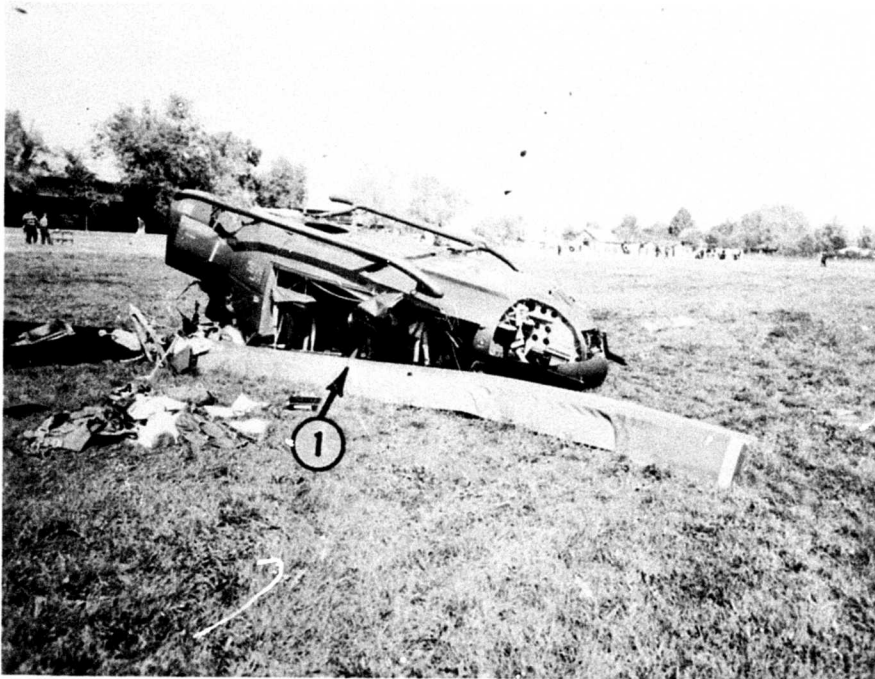
Fig. 10. Left side of aircraft. Transmission and rotor head, mast, and blades were broken to the left (about 90 degrees). Left vertical roof supporting member is also buckled (arrow 1).

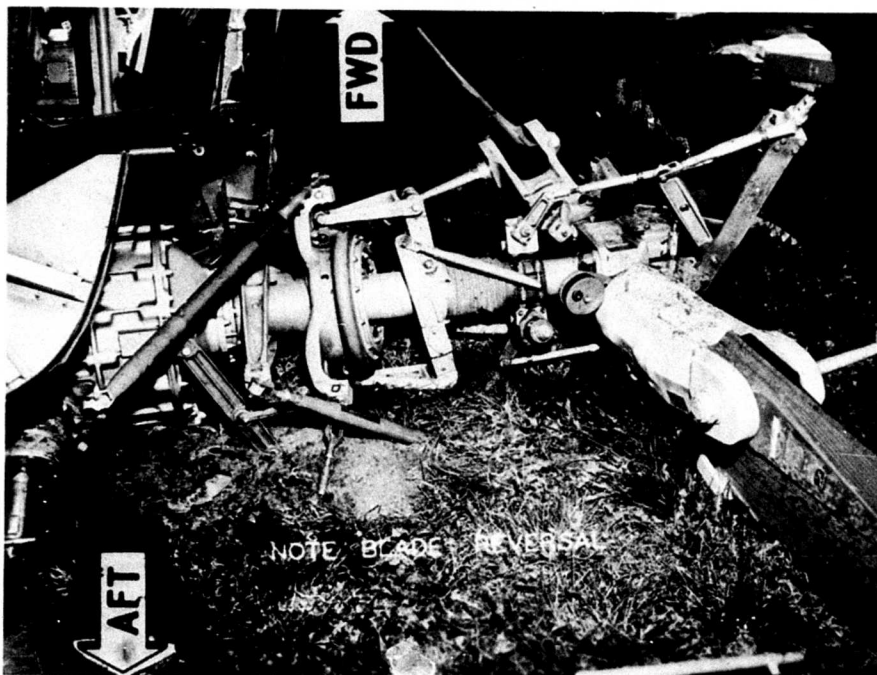
Fig. 11. Transmission, mast, head and blades broke off as a unit to the left.

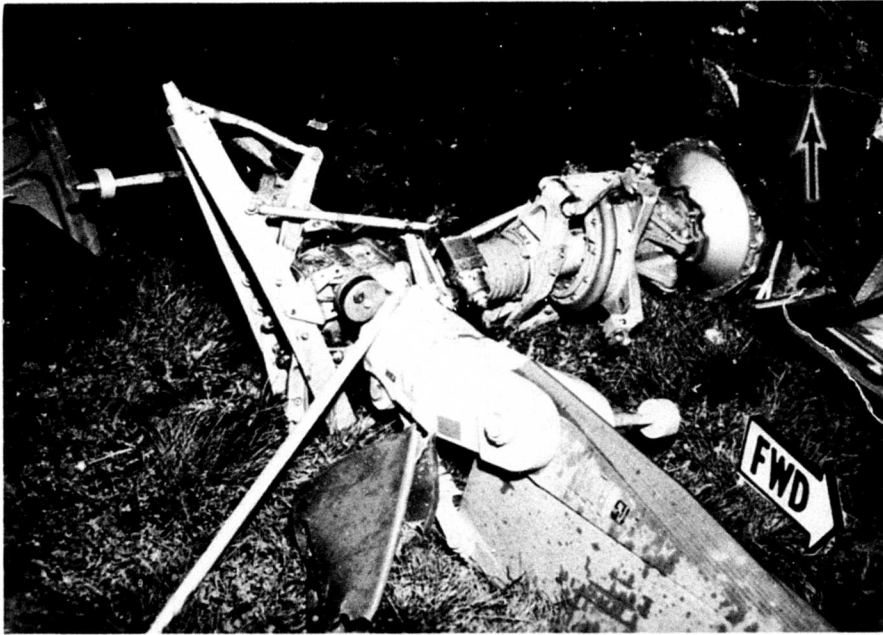
Fig. 12. Transmission, mast, rotor head and blades viewed looking aft. Left fuel cell area is shown (arrow).

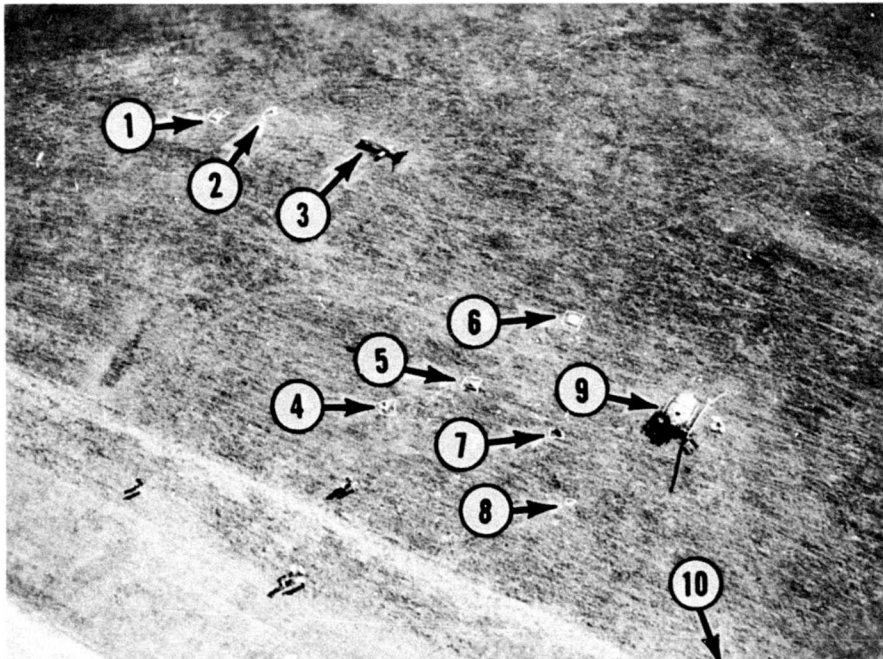
Fig. 13. Aerial view of main wreckage area. Arrows indicate the following: 1, left forward door; 2, right forward door; 3, tail boom; 4, cowling; 5, left engine cowling; 6, left cargo door; 7, cowling; 8, tail rotor drive shaft piece; 9, fuselage; 10, direction of engine.

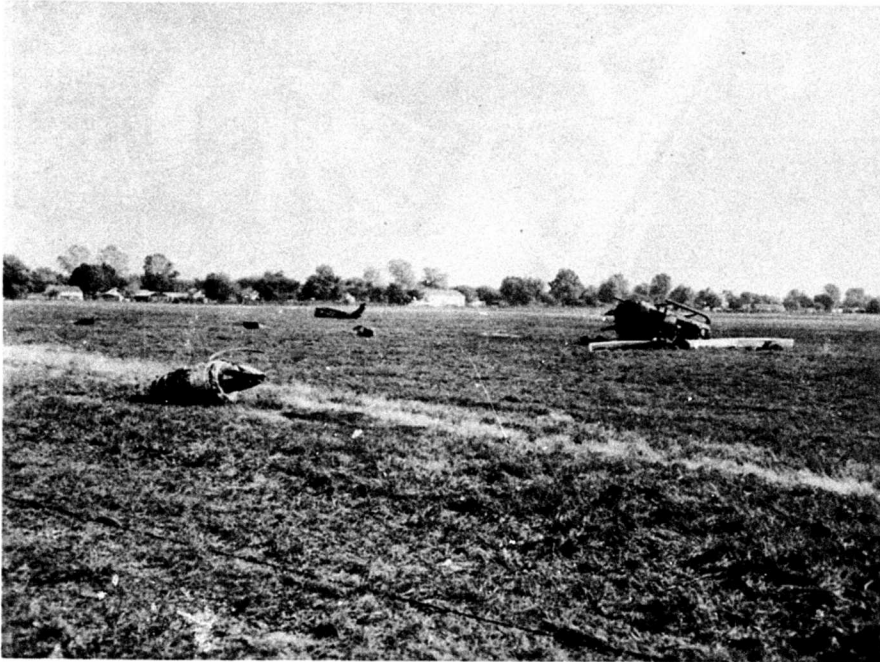
Fig. 14. Ground view of main wreckage area.

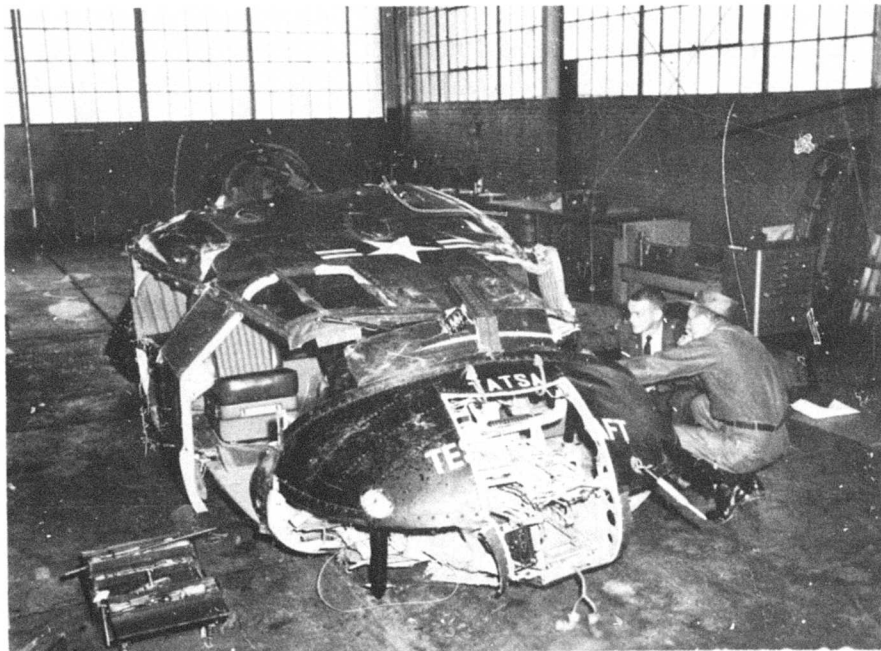
Fig. 17. Front view, aircraft righted. Except for overall inward crushing of the cabin roof, only moderate damage was sustained by the roof structure.

The extreme forward portion of the roof is supported by the front door frames and a center strip of the windshield frame structure. (See structural drawing and photographs of damage in Fig. 17, p. 14; Fig. 67, p. 44). Both forward door frame members and the windshield frame in the center failed completely, and the forward edge of the overhead structure crushed inward 18 to 24 inches.

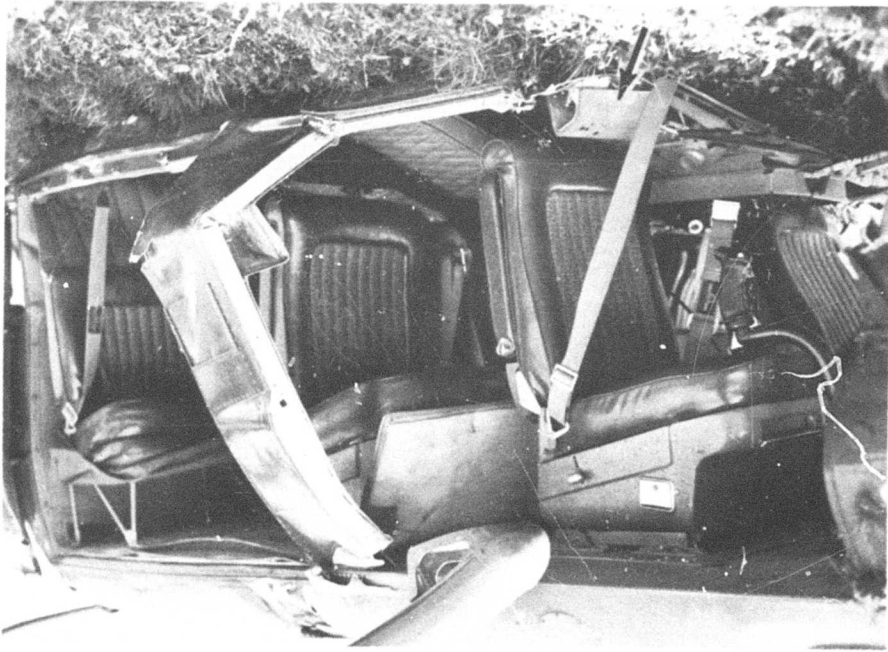
Fig. 18. Right side of fuselage. Note that overhead structure (roof) is impinged on top of the pilot's seat. The windshield wiper motor (arrow 1) was forced downward into the area normally occupied by the pilot's head.

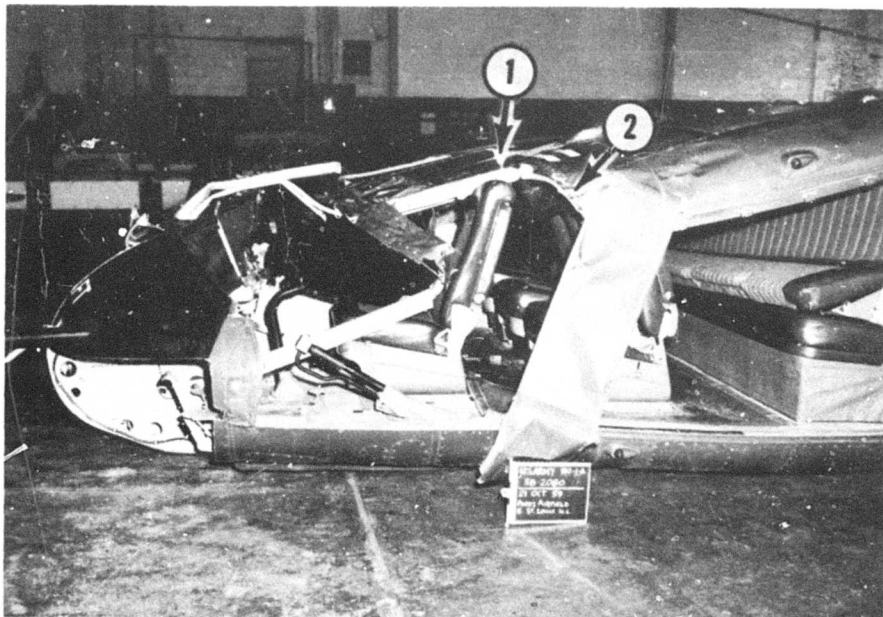
Fig. 19. Left side of cabin. The overhead structure on this side also impinged on the occupiable area. Note that the overhead structure is resting on both the copilot's seat back (arrow 1) and the second row of seats (arrow 2).

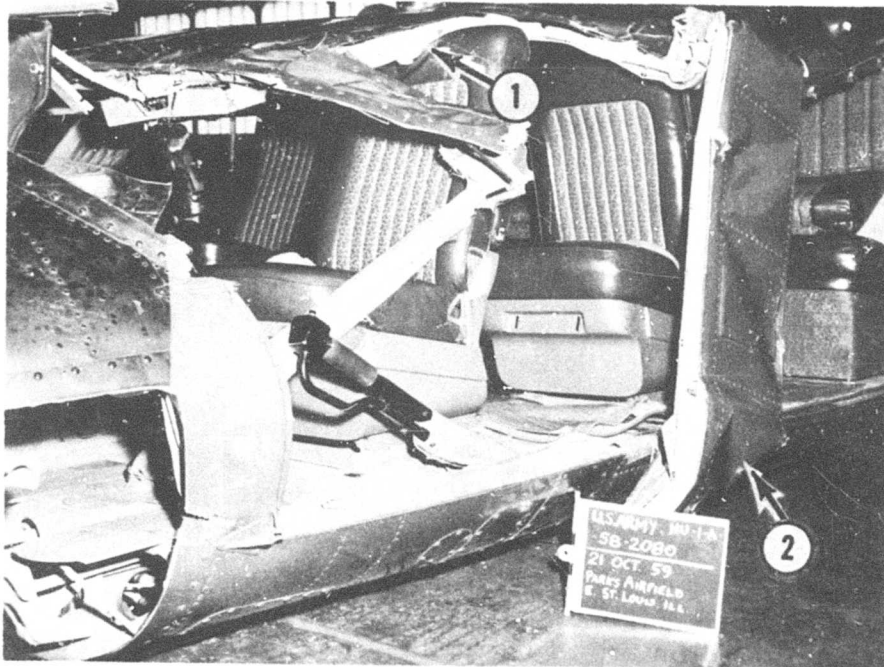
Fig. 20. Left side of cabin. Note that the copilot's seat top is supporting the overhead structure (arrow 1). Note the failure of the vertical support member (arrow 2).

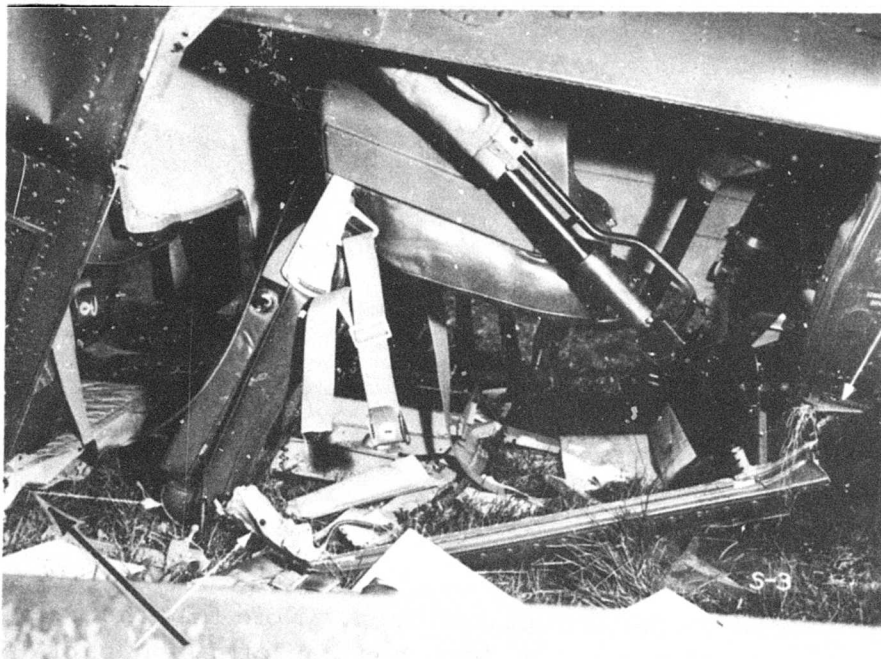
Fig. 21. View of aircraft inverted. Note that roof is impinged on top of passenger seat behind the copilot's seat (arrow).

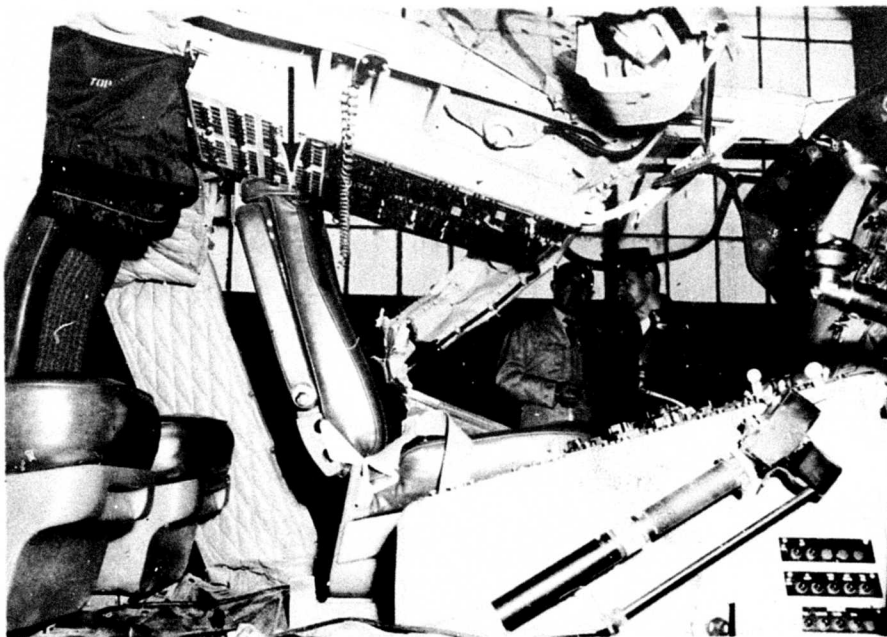
Fig. 24. View of copilot's environment (the pilot's seat has been removed). Note that the overhead console failed downward and impinged on the top of the copilot's seat (arrow).

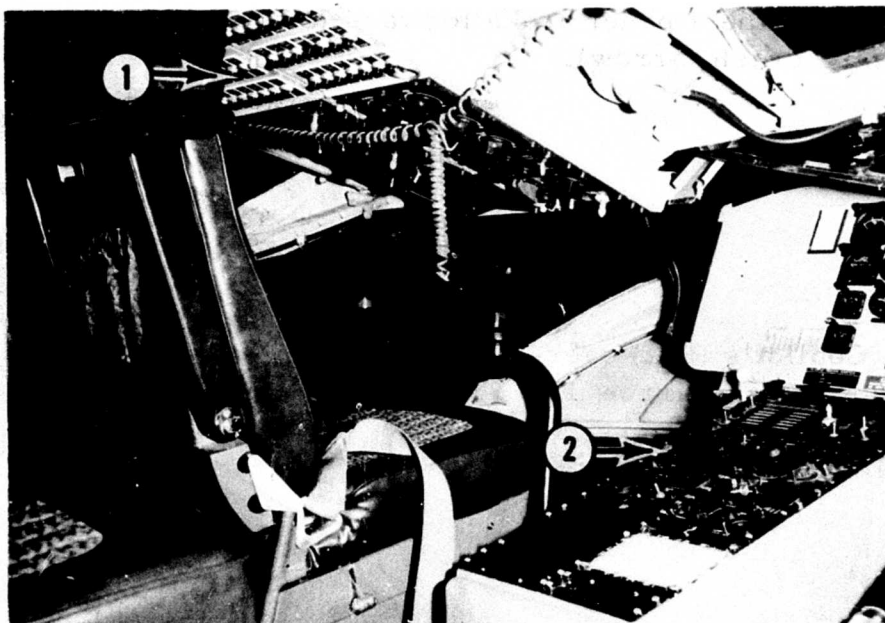
Fig. 25. Overhead console (arrow 1) presents hazardous condition when allowed to crush inward. Lower control console (arrow 2) offers no protection (padding) against injuries, which would be produced through forceful contact. In this accident no serious injuries occurred as a result of this condition.

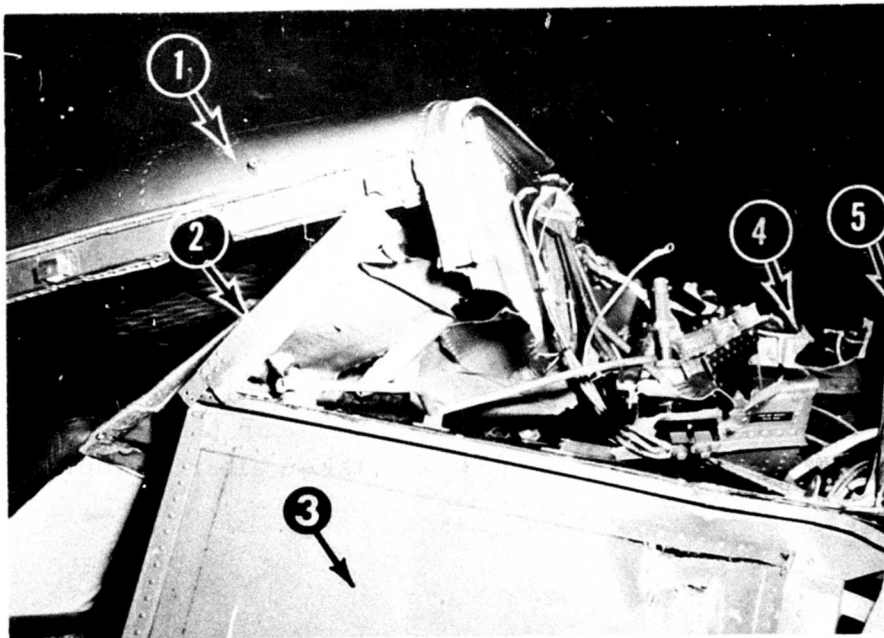
Fig. 26. Left side of HU-1A, showing overhead (roof) structure (arrow 1), aft cabin firewall bulkhead (arrow 2), left fuel cell area (arrow 3), rotor transmission (arrow 4), and forward engine firewall support (arrow 5).

First of all, the roof is supported at its aft end on a secondary type of structure; that is, the aft firewall bulkhead. (For distortion of bulkhead see Figs. 26-29, pp. 19-20). About two-thirds of the way forward from this point it is supported on the left and the right by vertical support members. During this accident both of the vertical support members failed outward in compression and allowed the forward portion of the roof to come down into the cabin. (See Figs. 18-19, p. 15; Figs. 66-74, p. 43 ff). The aft end, supported by the bulkhead, failed aft as the upper portion of the bulkhead failed in compression; as a result, the aft end of the roof moved aft and downward.

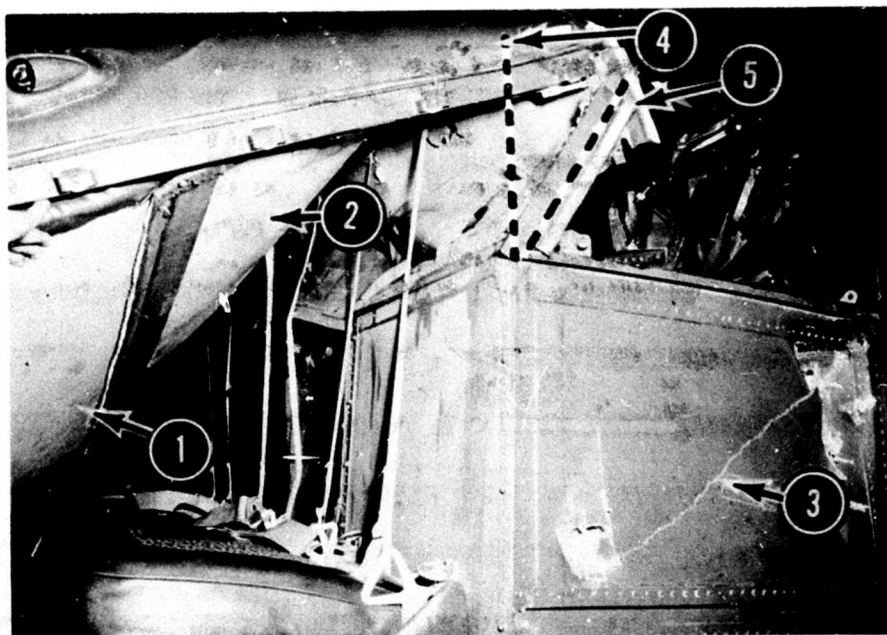
Fig. 27. Left aft cabin. Seat back (arrow 1) and upper padding (arrow 2) are pulled forward exposing aft cabin bulkhead firewall, left fuel cell area (arrow 3). Dotted line (arrow 4) indicates normal configuration of aft cabin upper bulkhead firewall, which is broken and buckled back to position shown by dotted line (arrow 5).

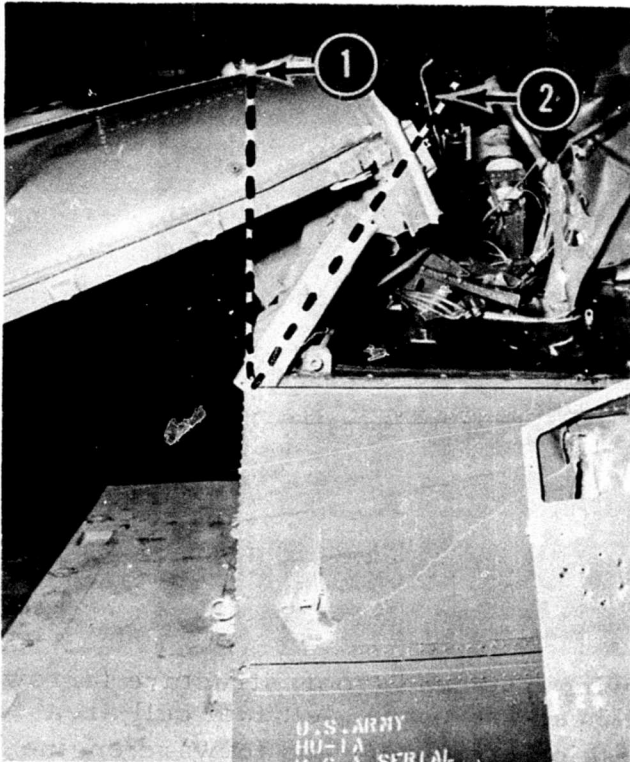
Fig. 28. Normal position of bulkhead (arrow 1); distorted position (arrow 2). Photo taken after stripping of cabin.

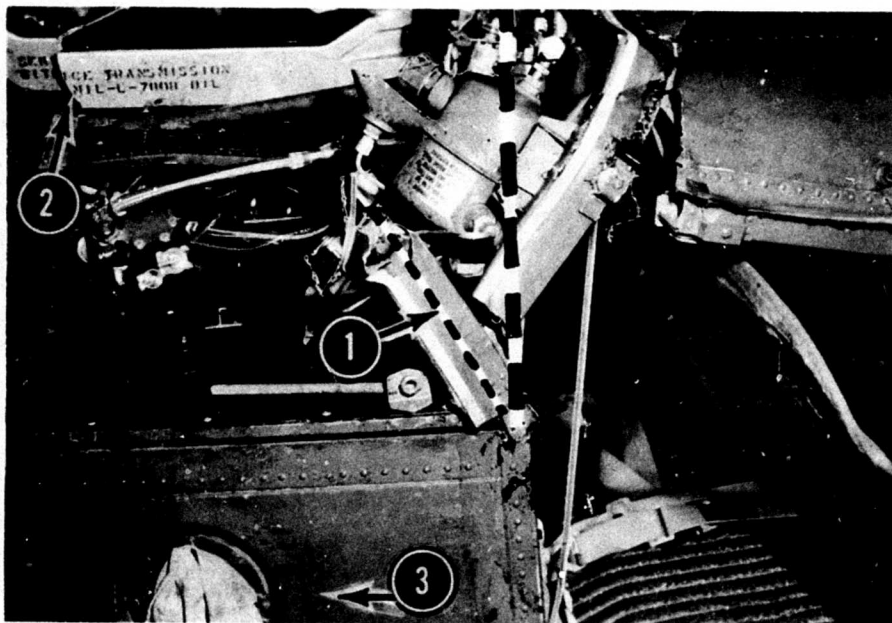
Fig. 29. Right side, aft cabin bulkhead firewall area. Heavy dotted line indicates normal position of firewall frame (arrow 1). Note cracked rotor transmission (arrow 2). Arrow 3 indicates right fuel cell area.

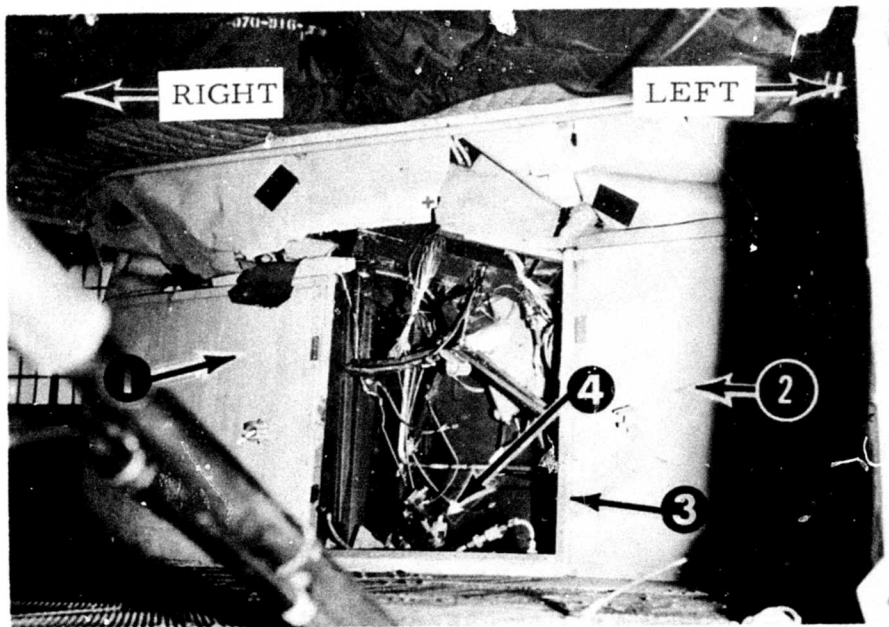
Fig. 30. Aft cabin bulkhead, showing fuel cell area, right (arrow 1) and left (arrow 2). Hoist well (arrow 3) and hoist coupling (arrow 4) are located between fuel cells. Seats and floor covering are removed to reveal intact floor, without the slightest distortion.

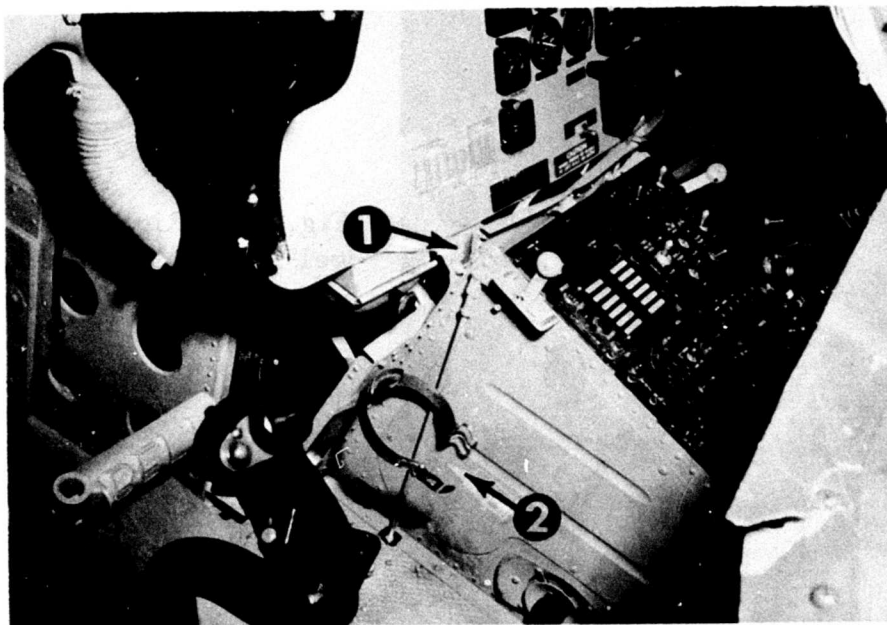
The instrument panel, even though loosened by impact forces and displaced slightly forward, sustained very little damage and remained intact. (See Fig. 22, p. 17; Fig. 31, p. 21).

Fig. 31. Instrument panel and control console on copilot's side (left). Note that instrument panel is broken forward, away from occupant (arrow 1). Arrow 2 indicates the fire extinguisher mount.

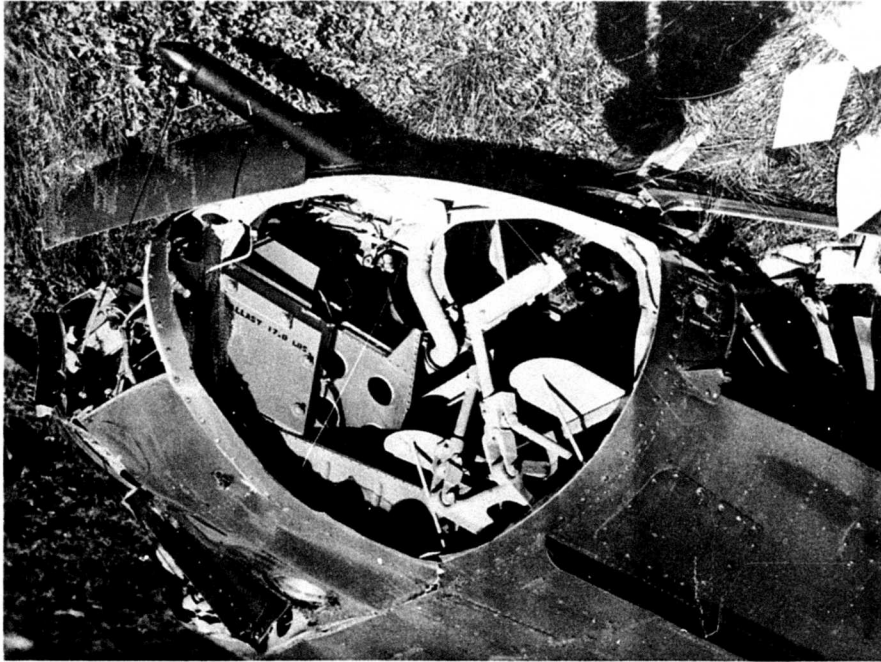
Fig. 32. Left (copilot) pedal well. Except for broken plexiglass, this structure was relatively intact.

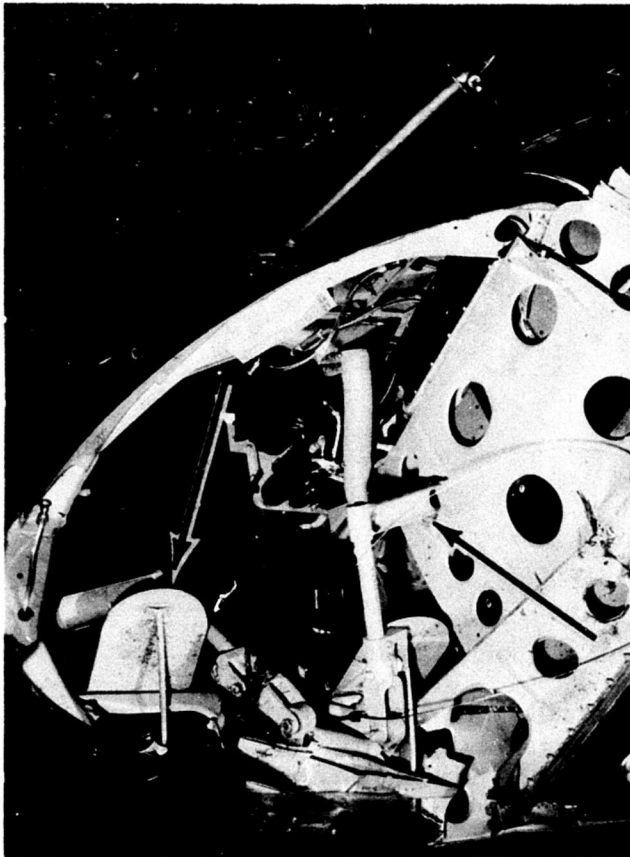
Fig. 33. Right (pilot) pedal well. Pedals (arrows) were broken during gouging.

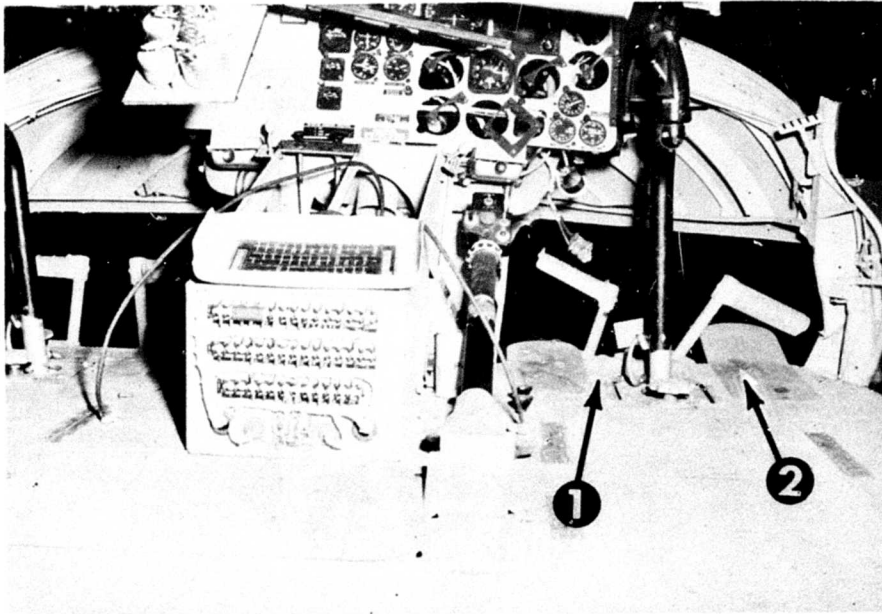
Fig. 34. Cockpit area with pilot's and copilot's seats removed. Note that the floor structure is intact except in that area below the pilot's rudder pedals (arrows 1 and 2). Note the damage to pilot's pedals. (Several instruments and a portion of the console were removed prior to photographing.)

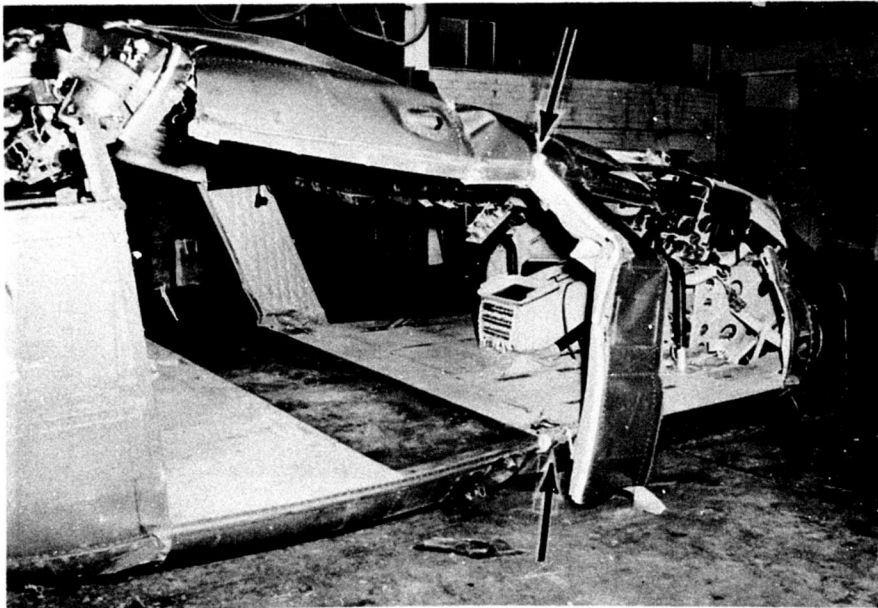
Fig. 35. Right side fuselage (seats removed). Note compression and failure of vertical overhead support member, which allowed overhead structure to crush downward. (See Fig. 67).

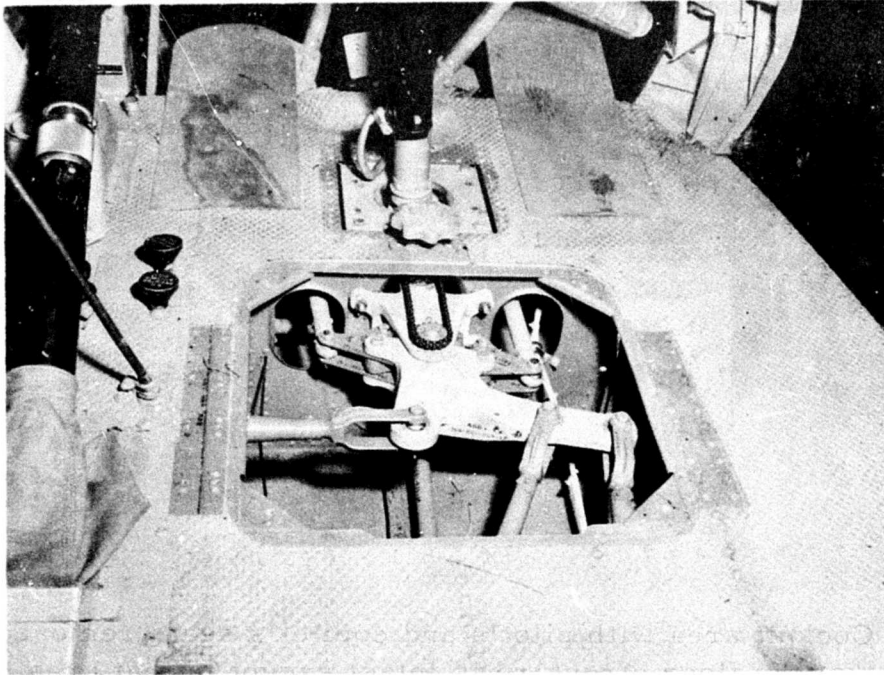
Fig. 36. Right front (pilot's) floor area with control access plate removed to determine whether any hidden damage existed. None was found. Pilot seat mounting plate was fastened to floor over this access area.

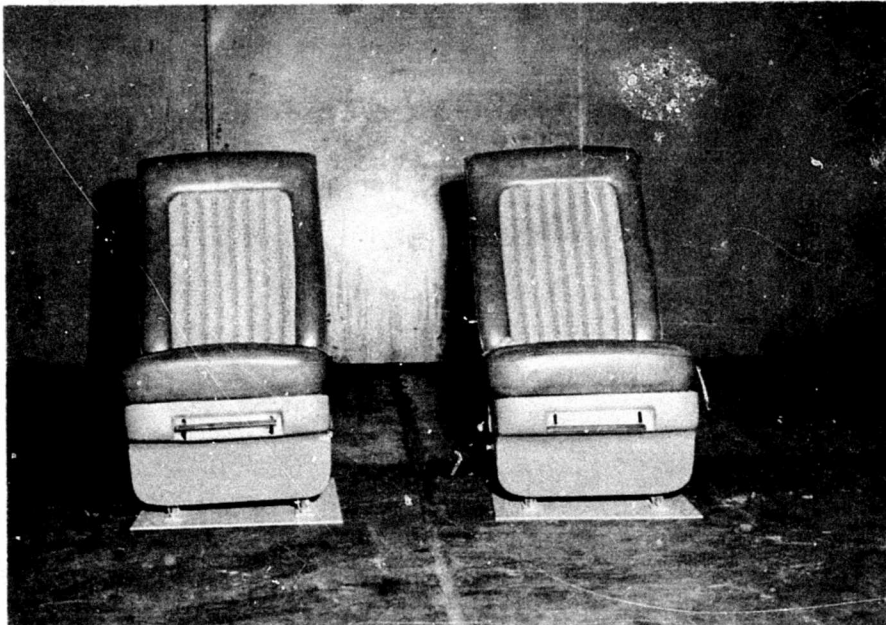
All of the seats in the cockpit and cabin area remained intact and in their normal positions following the crash. However, both the pilot's and the copilot's seats revealed slight distortion to the right. (See distortion in Figs. 37-38, p. 24 ff.) There appeared to be no other damage to the seats.

Fig. 37. Pilot (left) and copilot (right) seats - removed from the aircraft. Slight distortion to the right (on both seats) is visible.

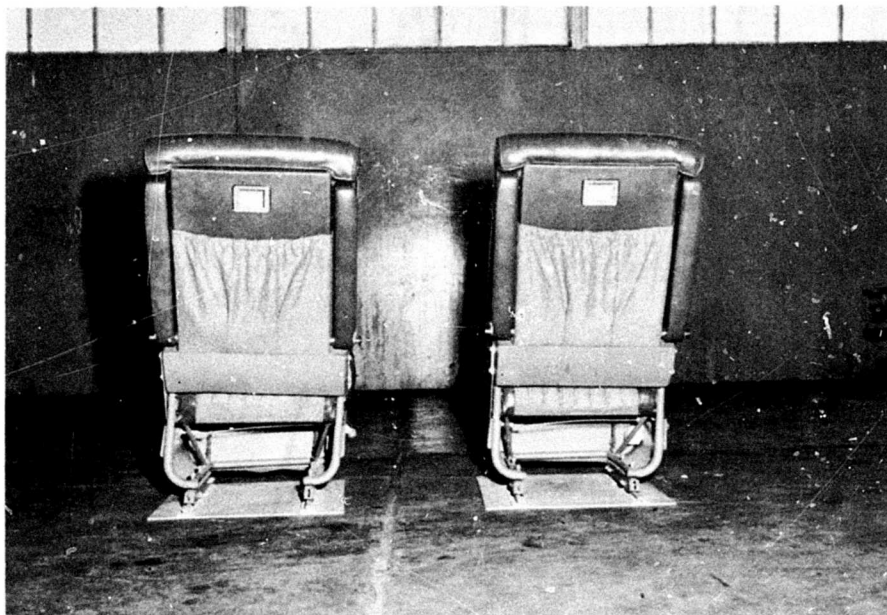
Fig. 38. Pilot (right) and copilot (left) seats. Distortion to the right is more noticeable from this view. Note mounting plates used to install this "special" seat in the demonstration HU-1A.

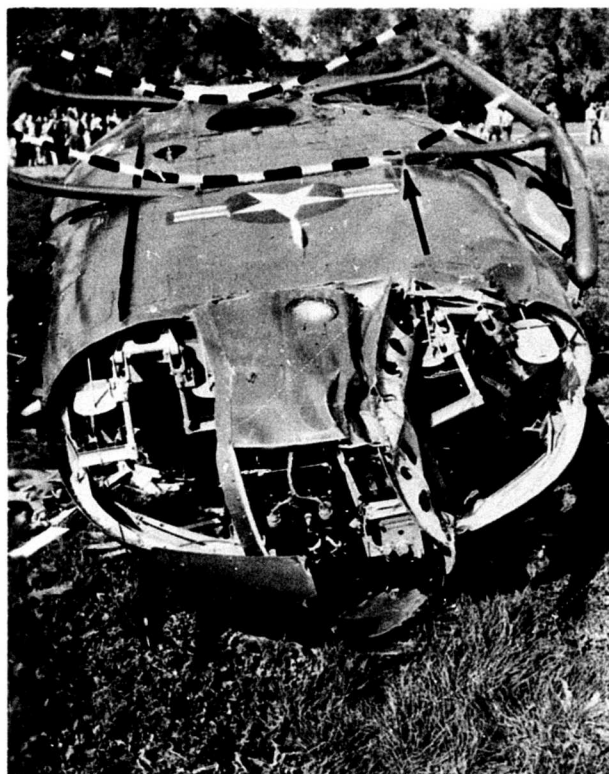
Fig. 39. Front view. Note front right cross-tube failure (arrow). Dotted lines indicate approximate normal cross-tube configuration. Damage incurred to the fuselage is greater on the right side. Although distorted, the rear cross-tube did not fail.

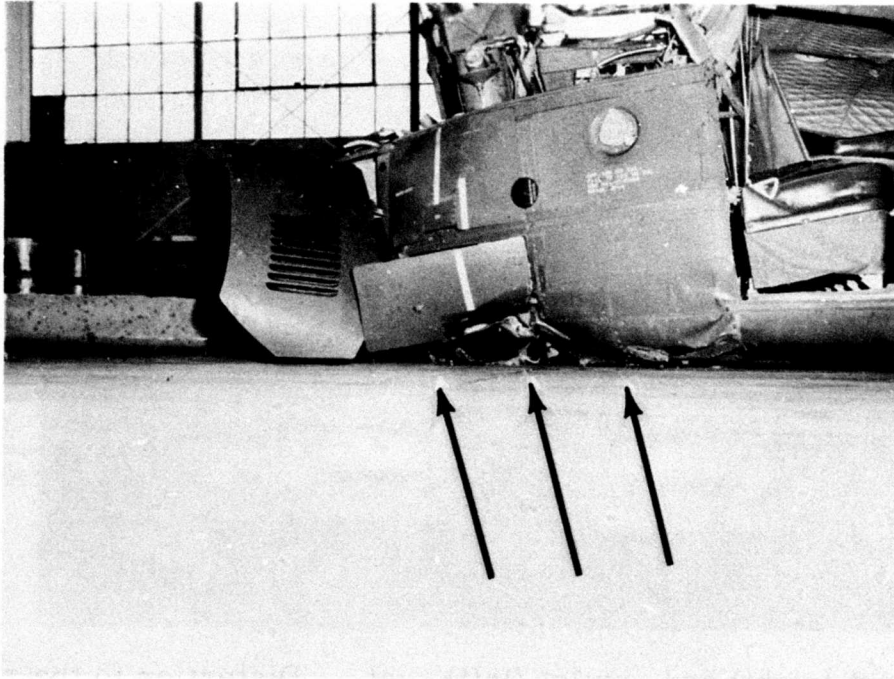
Fig. 40. Aft right fuselage. Arrows indicate fuselage belly area (believed to have been damaged at initial impact).

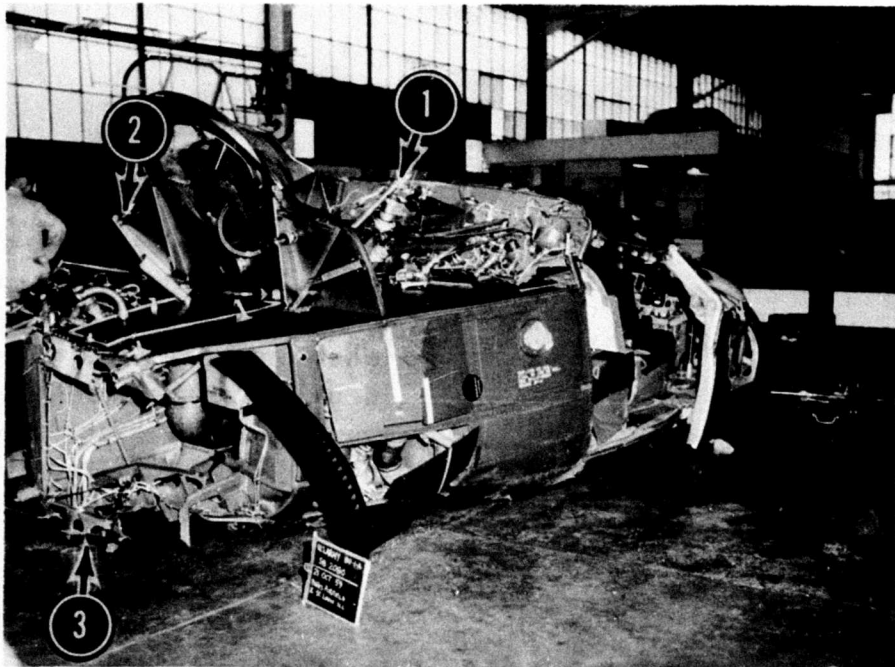
Fig. 41. Aft right fuselage, showing position for rotor mast and transmission (arrow 1), engine area (arrow 2), tail boom attachment (area 3).

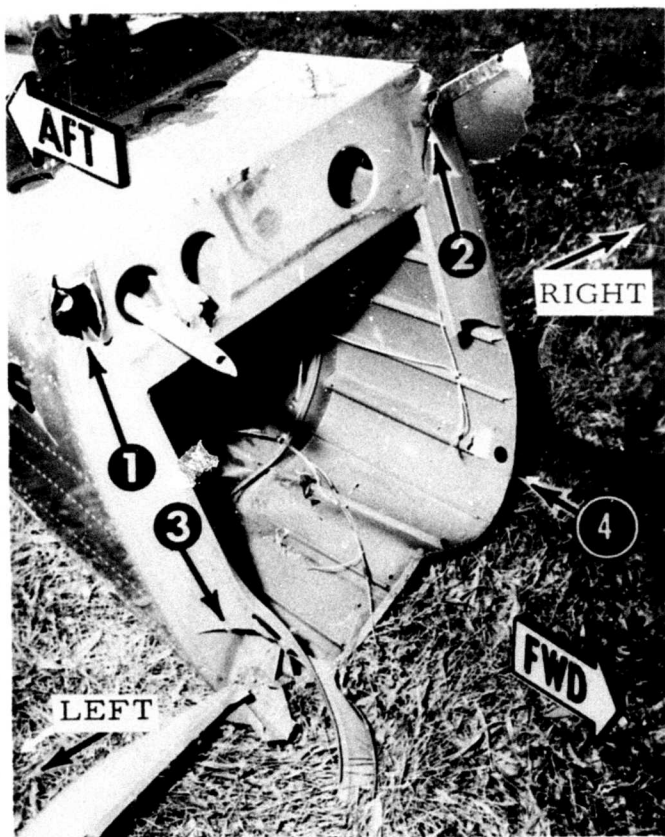
Fig. 42. Forward end of tail boom. Upper right (arrow 1) and upper left (arrow 2) attaching points failed at initial impact - in tension. Lower right (arrow 3) point failure was first in compression, then tension. Lower left (arrow 4) failure was primarily in compression.
